Tracking the Tempests: The Creation of the SSMIS

January 1999

A. A. FOTE
Electronic Systems Division
Engineering and Technology Group

SPACE AND MISSILE SYSTEMS CENTER
AIR FORCE MATERIEL COMMAND
2430 E. El Segundo Boulevard
Los Angeles Air Force Base, CA 90245

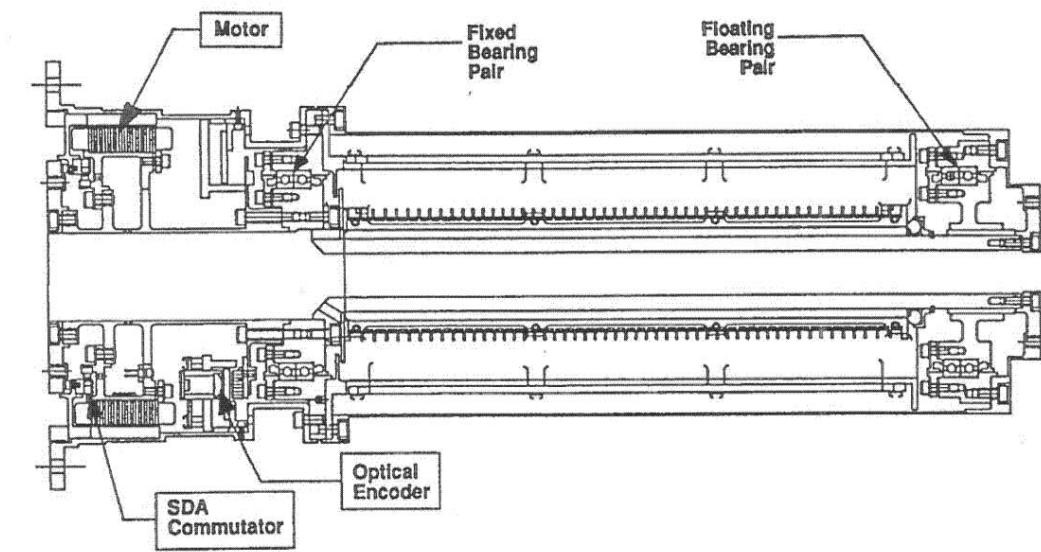
Figure 9. Sketch of the scan drive assembly.

After a lengthy investigation, involving several false trails, Aerojet, by September, had narrowed the source of the corruption to the scan drive assembly, and in particular, to the slip rings through which the encoder signals pass. They next examined other scan drive assemblies for the problem and found that the engineering model, and only the engineering model, shared the phenomenon. In consequence, Aerojet again reset the delivery schedule for Flight Unit #1, to March 15, 1997.

explanation envisioned the reaction of the molybdenum disulfide lubricant with water vapor to form an insulating, and sticky residue of molybdenum trioxide particles. Spinning the assembly accelerates such a reaction but it will occur even under static conditions, albeit very slowly. Although Aerojet only operated the scan drive assembly under vacuum or dry nitrogen purge, some water vapor inevitably enters the assembly. Meanwhile, the assembly suffered considerable time exposed to atmospheric conditions while stationary.

At this point, they expected to repair the scan drive assembly, without removal from the sensor, with the addition of a few wiring modifications. They based this on an experiment which they had conducted on the engineering model at the suggestion of the manufacturer, Honeywell. Specifically, they had passed a 1-amp current through one of the noisy slip-rings for a period of 10 minutes. At the end of this time, they discovered the ring completely cured. In fact they reported it the "quietest ring" they had ever seen. However, they failed to duplicate this success with Flight Unit #1 and so, in October, they ceased further experiments and began disassembly of the sensor in order to replace the scan drive assembly.

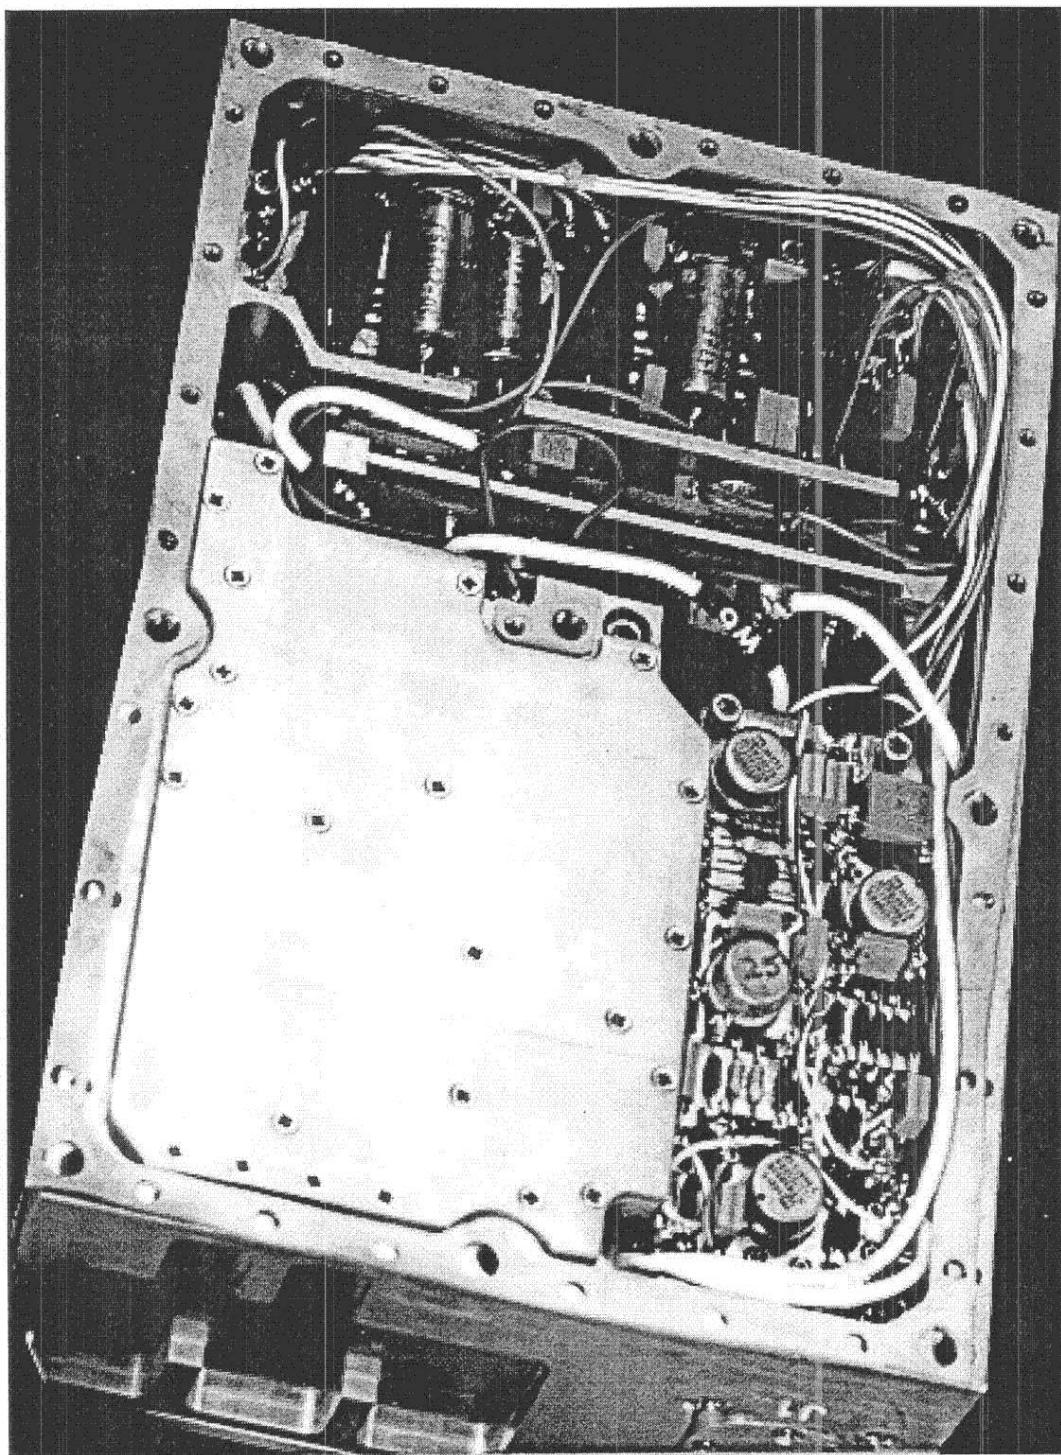
Figure 12. Phase-locked oscillator with cover removed.

Altogether, in a box 5.7 x 3.9 x 1.9 inches, the PLOs contain a 56-GHz Gunn diode oscillator, a 56-GHz harmonic mixer, a 6.7-GHz and a 4.5-GHz dielectric reference oscillator, a 141-MHz oven controlled, voltage controlled, crystal oscillator, and associated amplifiers and power supplies. The vendor must carefully tune the circuits to eliminate spurious harmonic output frequencies and cross coupling of signals. And, usually, repair of one circuit disrupts the operation of the other circuits due to their close proximity in the small volume.

A better approach would have involved a modular design, with the separate functions isolated from one another and capable of individual replacement. However, such a partitioned arrangement would not have met the size and weight restrictions.

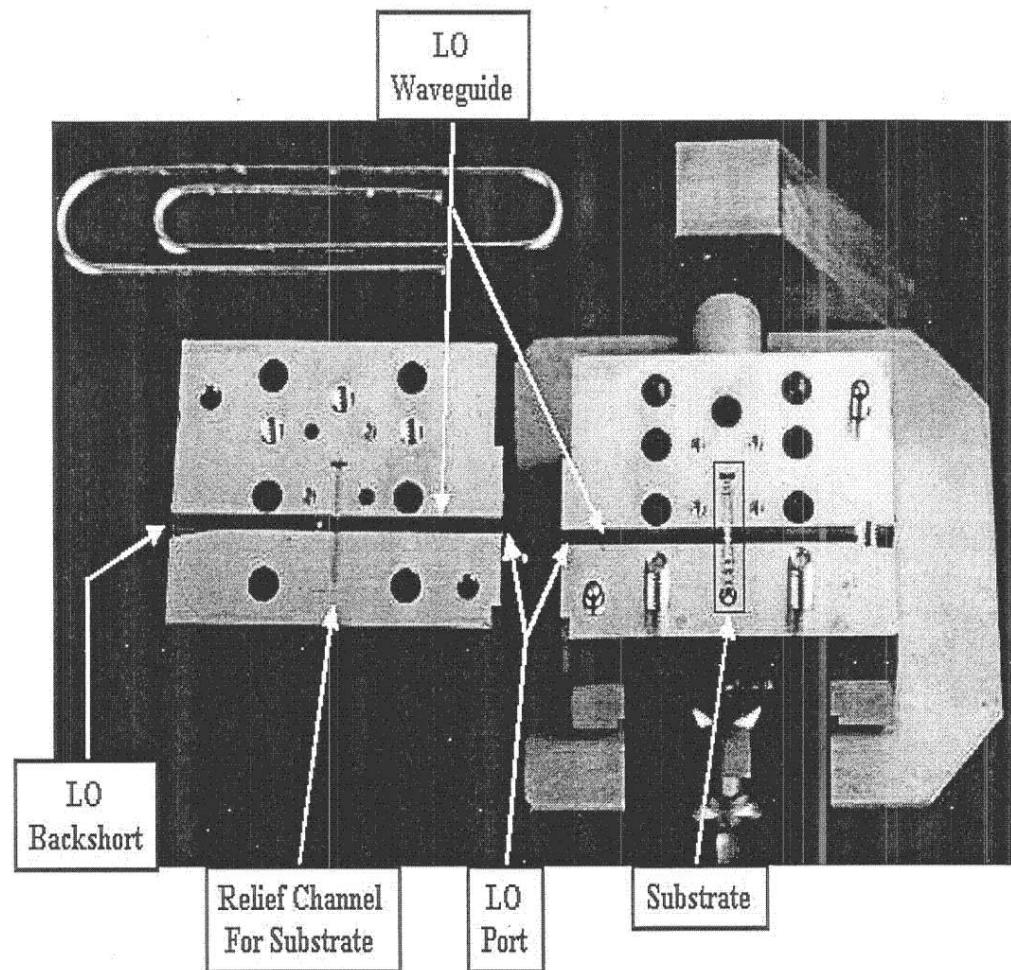
Figure 14. G-Band Mixer Internal Configuration.

Two 2-mil wide gold ribbons establish electrical contact between the diode end of the substrate and the brass housing. Only after many failures and much experimentation was Aerojet able to position the substrate and attach the wires to obtain stable and reliable mixers. Early mixers exhibited poor stability from having the wires too long. Shortening the wires in later mixers led to fractured wires due to the lack of stress relief. Aerojet subsequently restored stress relief by incorporating an indium pad at the housing end of the wires. Meanwhile, they improved the design and assembly of the mixers in numerous other ways over the years.

Subsequent investigation revealed that the last mixer failed because of excess solder on the diode beam. Aerojet also concluded that they needed to change the mixer screening tests. Whereas they formerly tested over the temperature range of -30 to $+80^{\circ}$ C, they would now test from -45 to $+70^{\circ}$ C to increase the likelihood of discovering such workmanship problems at the component stage.

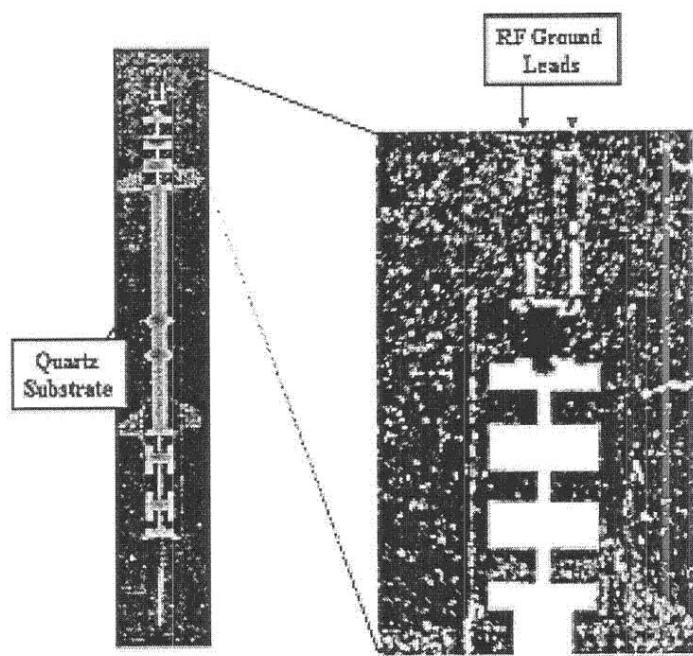
Figure 15. G-Band Mixer Substrate.

Nestled in a small cavity in the housing lies a quartz substrate (Fig. 15), 341 mils long by 30 mils wide by 3 mils thick. This substrate carries a thin metal film antenna for receiving the incoming signal microwaves from the feedhorn and the reference microwaves from the Gunn diode oscillator. The substrate also carries, at one end, a tiny microchip, 10 by 5 by 3 mils, carrying two parallel GaAs diodes. The diodes (Fig. 16) combine the two microwave inputs and generate, as a beat signal, an output in the form of a lower frequency intermediate frequency (IF) signal.

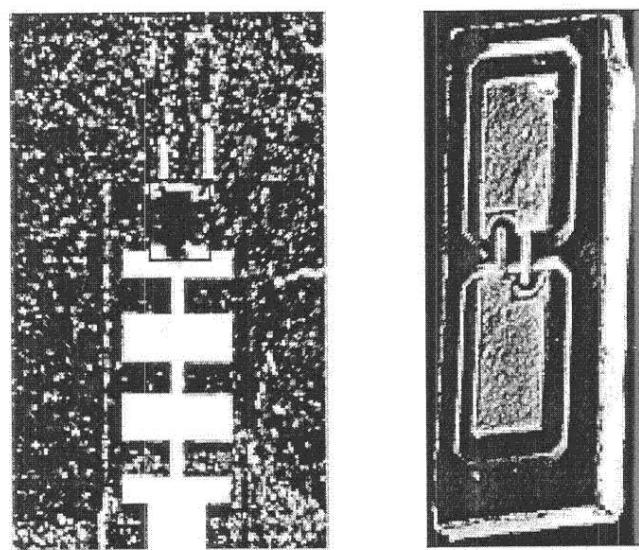
Figure 16. G-Band Mixer Diode.

Aerojet acquired the GaAs diode chips from the University of Virginia, the only source for devices of the requisite quality. The University of Virginia makes these diodes primarily for radio astronomers. They have a junction width of only 0.7 μm and a fragile three-dimensional construction structure consisting of two thin beams spanning an air gap; the structure resembles microscopic bridges over a chasm. Aerojet technicians must carefully solder these chips by hand onto the substrate, aligning its axis with that of the substrate as close as possible for optimum performance. The slightest amount of electrical overstress will destroy these devices.
